## 7.0 Non-Aboriginal context

### 7.1 Historical overview

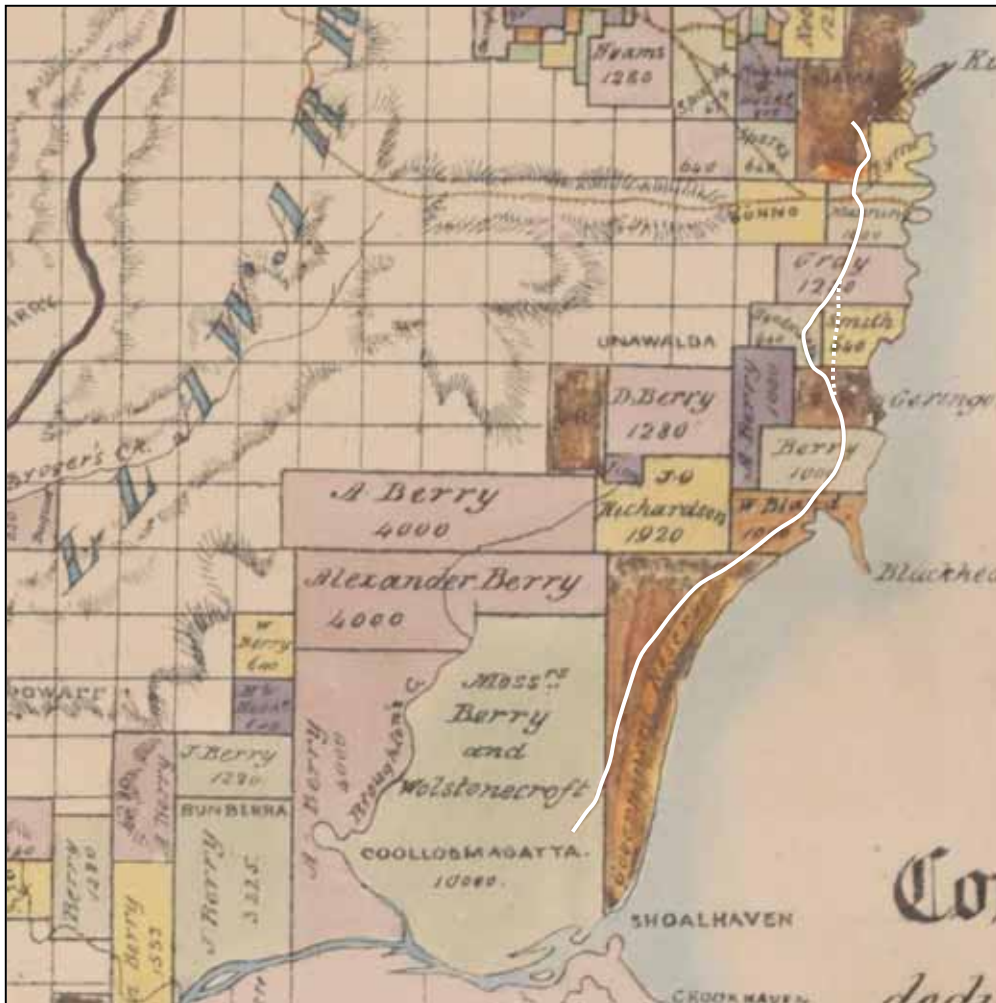
Figure 7.7: Extract from map of the County of Camden 1843 -46. The only road shown extending south from Kiama at this time (highlighted in white), passed through Gerringong and traversed Seven Mile Beach to Berry's settlement at 'Coolloomagatta'. Despite the schematic delineation of the road, it is clear that a shortened route across Omega Flat (dashed, across the Smith's portion), is paired with a more regularly used deviation around the swampland across Hindmarsh's portion.

Shortly after, a new line was marked to Gerringong to replace the old track which wound round the headlands (JME 1951:78; Cousins 1948:96). In 1844 it was noted that the Kiama to Gerringong road was not metalled (Cousins 1948:192).

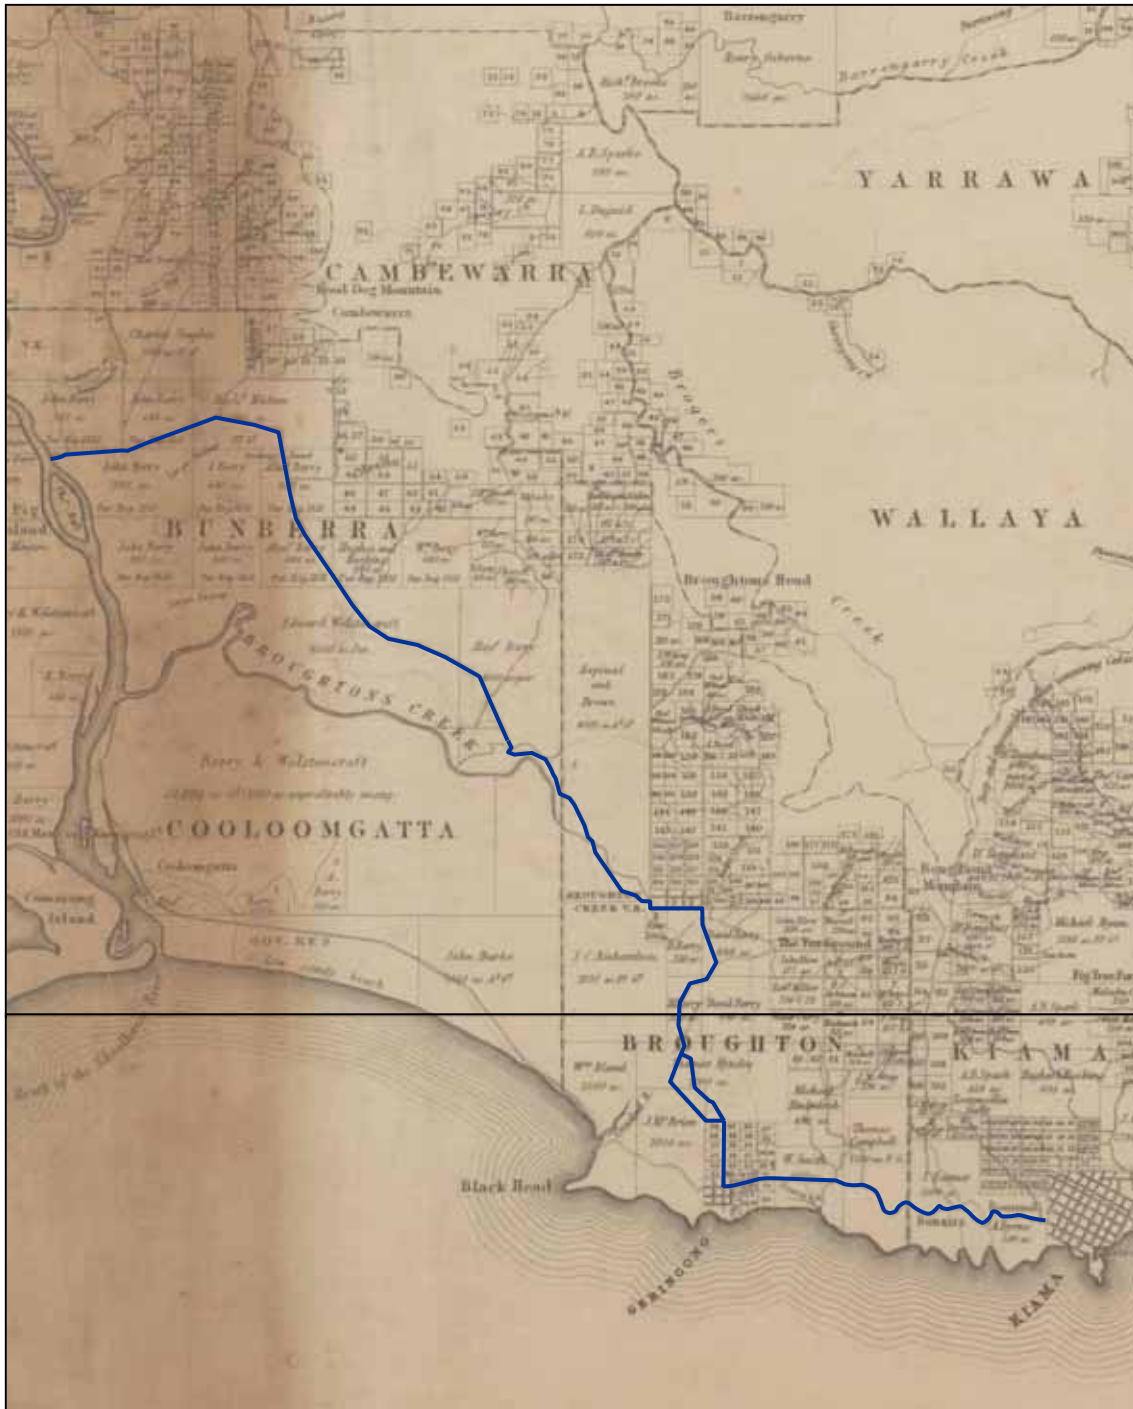
Figure 7.8: Extract from an 1866 map of the County of Camden, showing the location of roads between Kiama, Gerringong, Broughton Creek (Berry) and Bomaderry, highlighted in blue. Note the alignment of the Berry estate road between Gerringong and Bomaderry which comprises many straight sections with minimal bends and deviations.

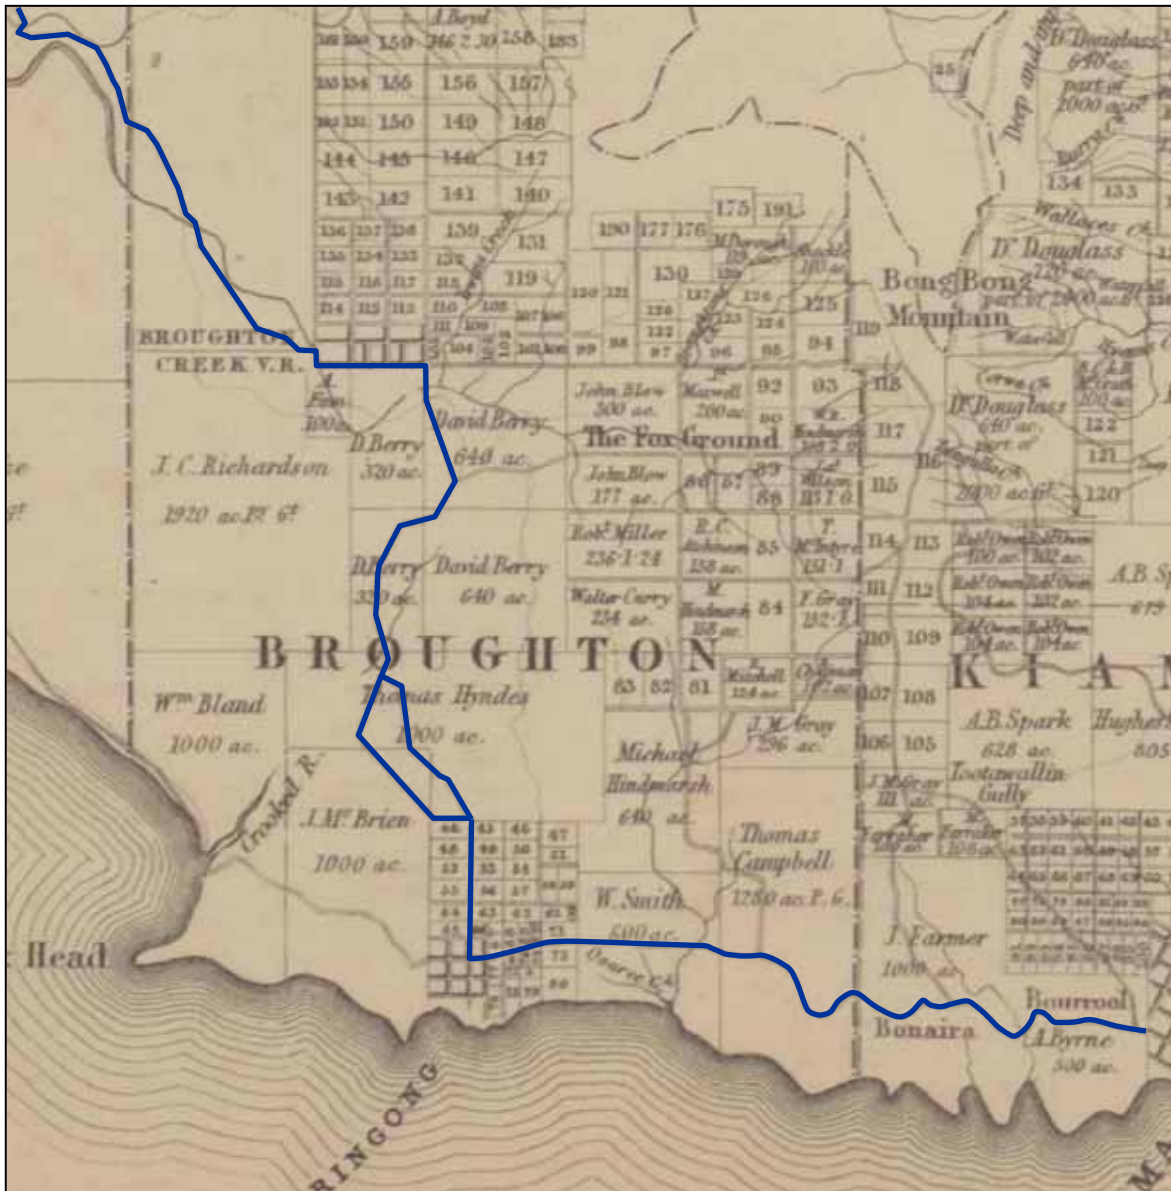
Figure 7.9: Extract from an 1866 map of the County of Camden, showing the location of roads in the vicinity of the Gerringong upgrade proposal area

In the period between Berry's original construction of the estate road from Gerringong to Bomaderry in the late 1850s, and the 1890s, the further development of the road by the local councils resulted in a longer and more angular alignment, involving switch-backs and deviations around spurs. This is evident in a comparison of the 1866 and 1895 County Maps (see Figure 7.8 to Figure 7.12). The elaboration of Berry's originally straight alignments appears to have been a consequence of establishing more gradual grades, suitable for horse drawn vehicles, and complying with various tenant farm boundaries and related cadastre.

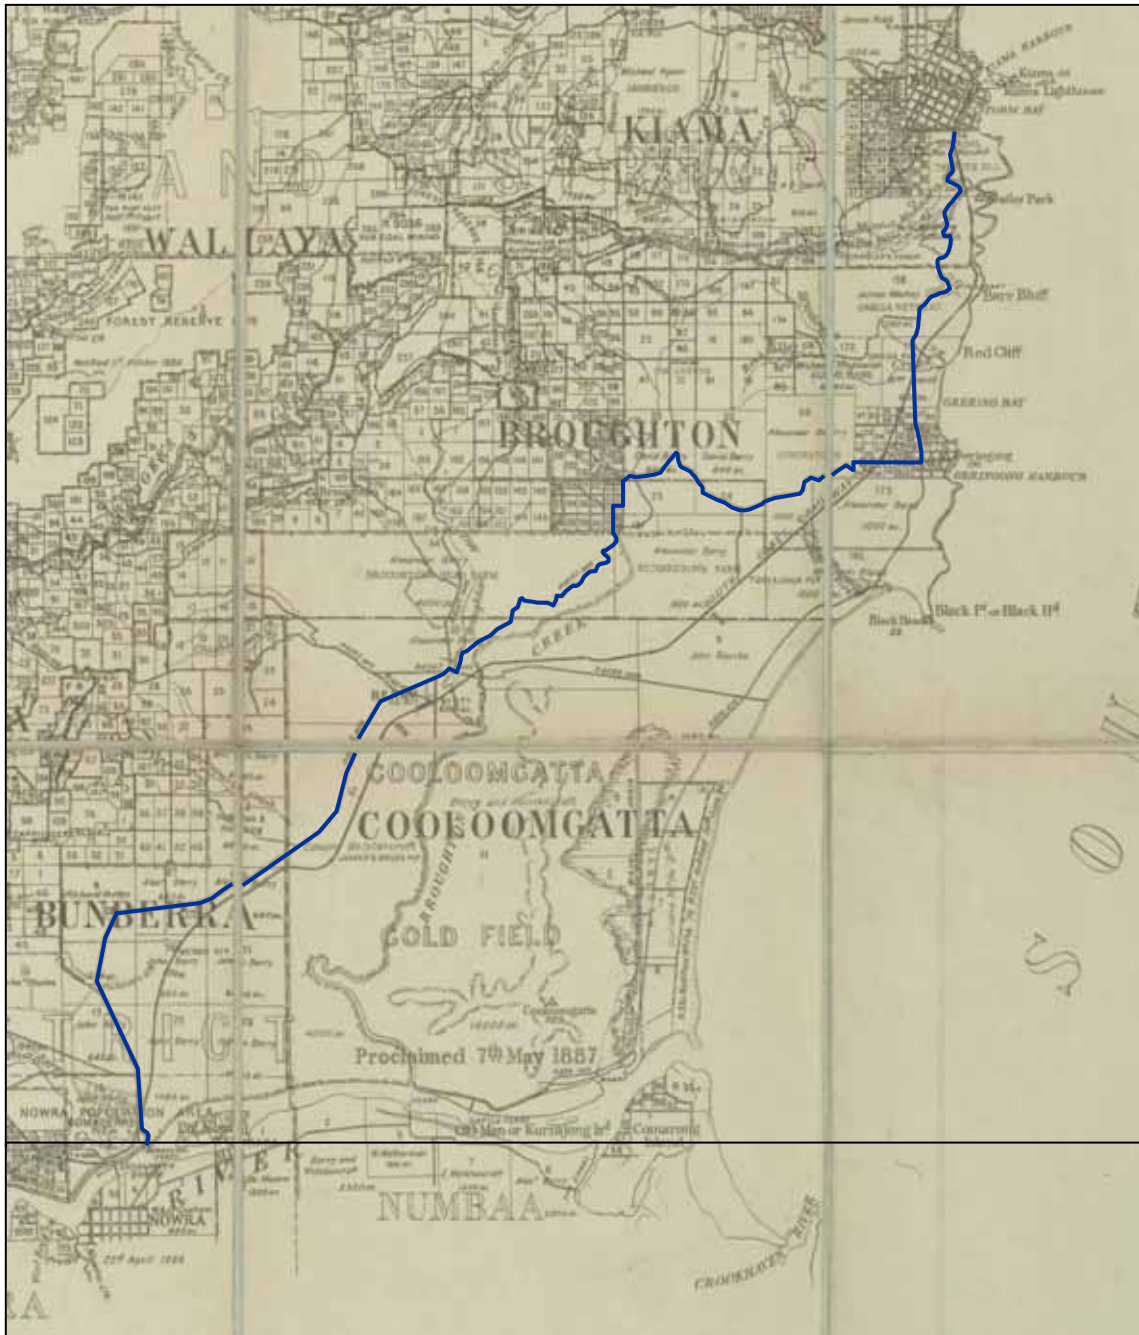
Figure 7.10: Extract of an 1895 map of the County of Camden, showing the road between Gerringong and Bomaderry. Note how the development of the road by local councils, and following the break-up of the Berry estates has introduced numerous bends and irregularities from Berry's original alignment

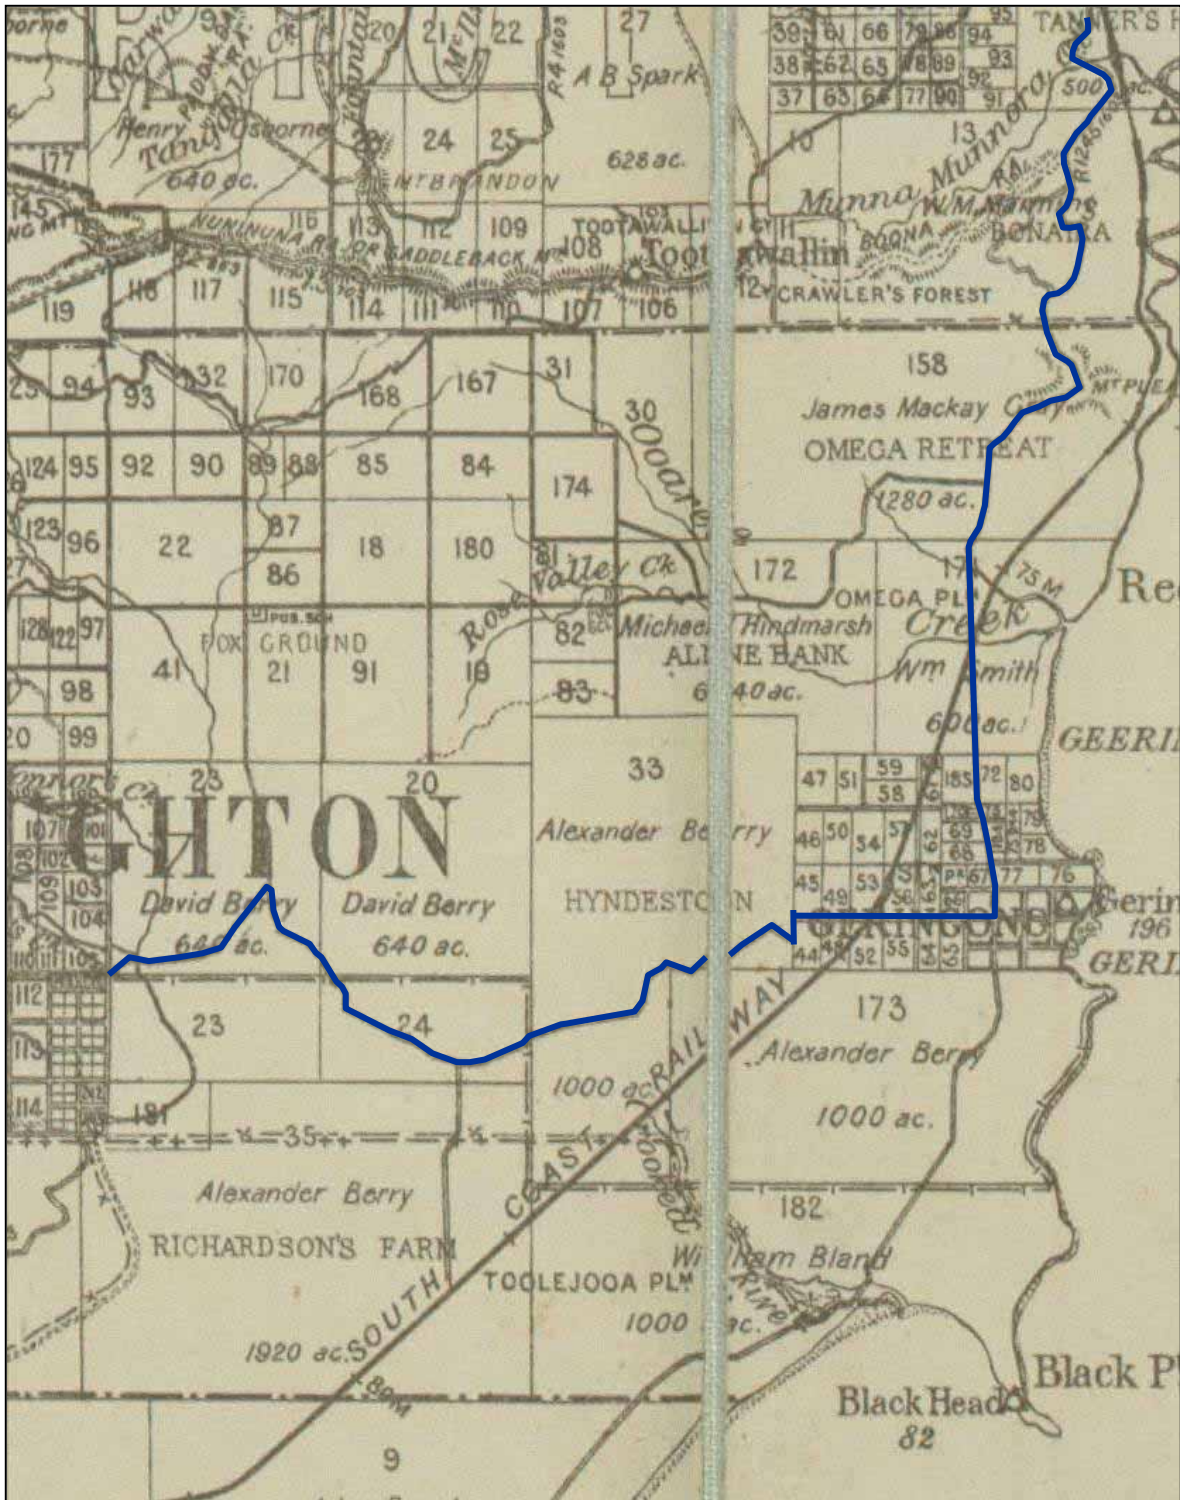
Figure 7.11: Extract of an 1895 map of the County of Camden, showing the location of the roads between Kiama, Gerringong and Broughton Village, the vicinity of the Gerringong upgrade proposal area

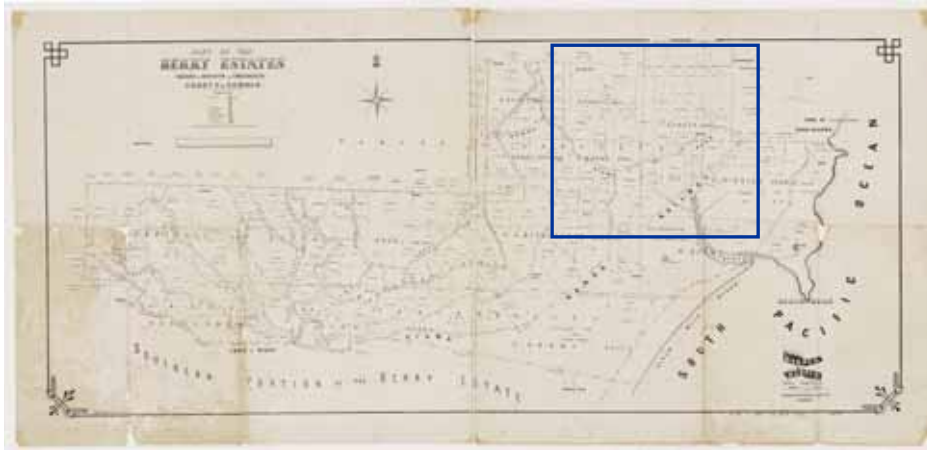
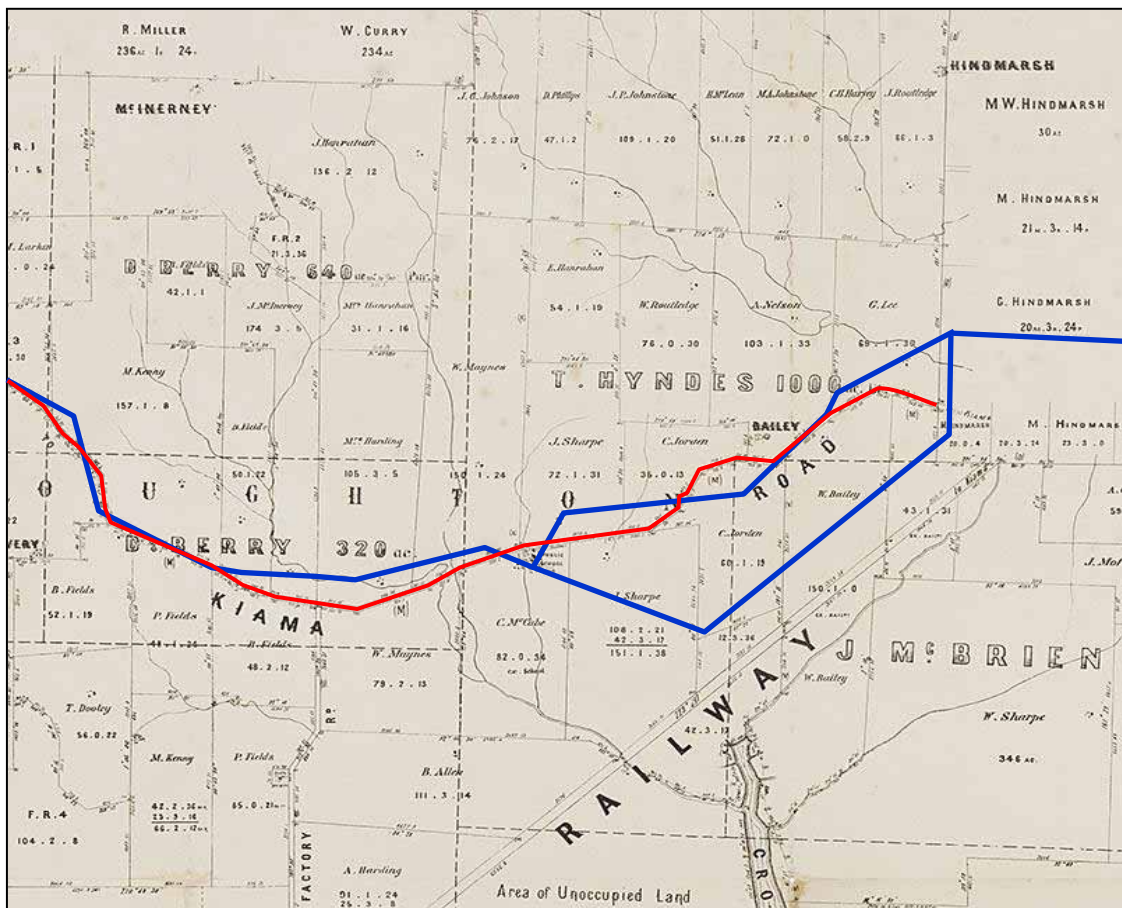
Figure 7.12: Extract from an early 1890s map (probably 1892, refer Graham 1998), of 'Part of the Berry Estates, Parishes of Broughton and Coolangatta, County of Camden'. The map records the boundaries of former tenant farms, their associated homesteads, and the road between Gerringong and Broughton Creek (Berry). The extract above shows the estate closest to Gerringong and within the Gerringong upgrade proposal area. The red line highlights the mapped roadway, the blue line is an approximate overlay of the road shown in the 1866 County map, and presumed to be the estate road constructed by Berry in the 1850s. Note that the 1890s road is more moderately graded, and deviates around cadastral boundaries.

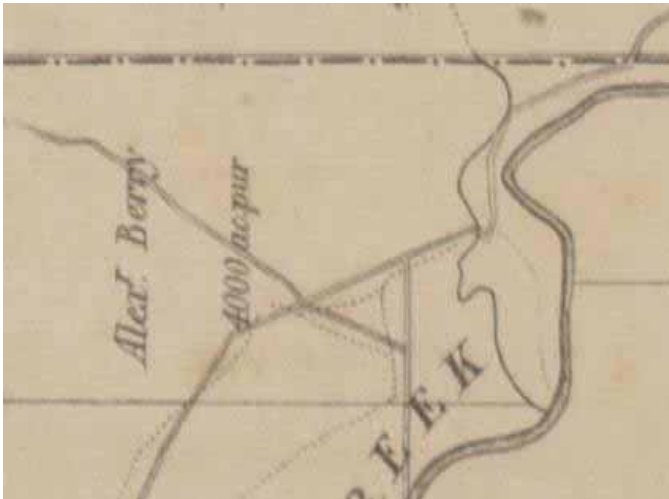
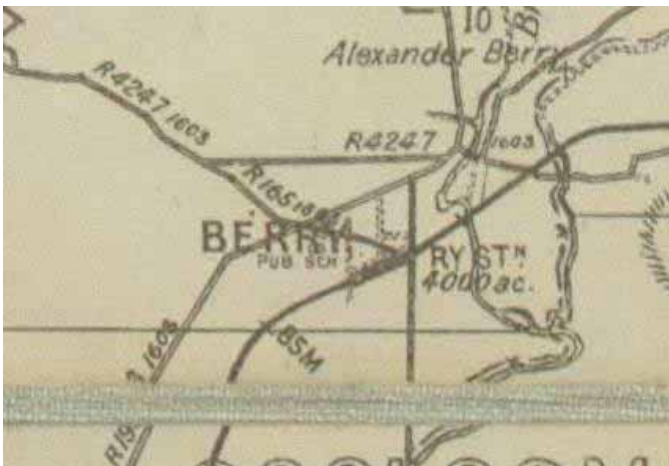
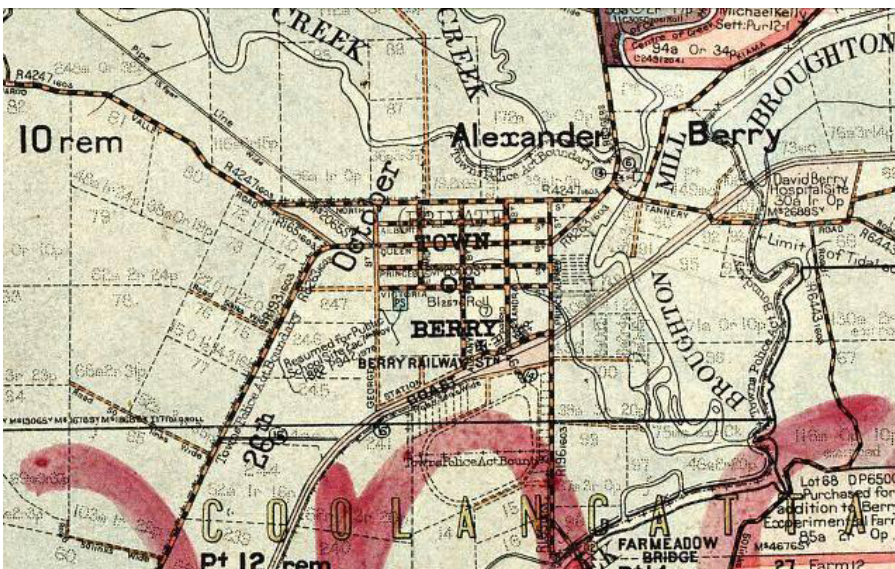
Figure 7.13: Extract from County and Parish maps showing the change in the orientation of the main south road through Broughton Creek (Berry), from a south-west to an east-west alignment occasioned by the establishment of a street grid in the 1880s

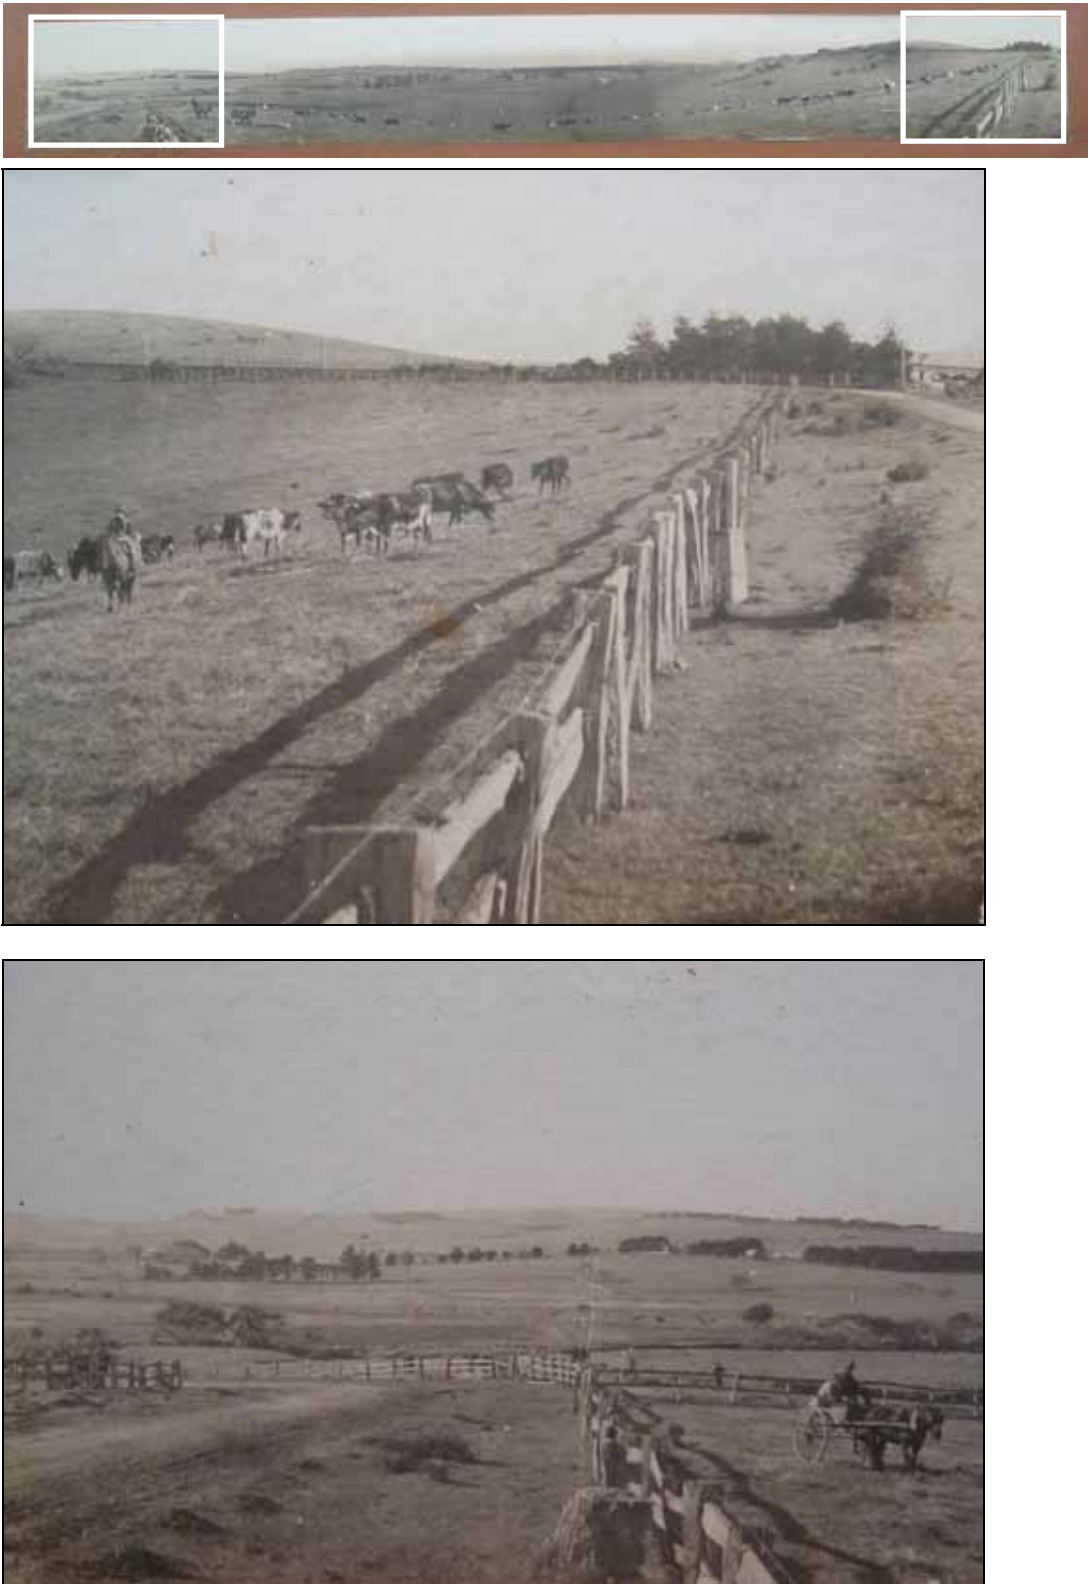
Figure 7.14: Extracts from a 180 degree panorama photo (top), looking roughly west (middle) and east (bottom), along the highway in the 1920s, from a point just west of Gerringong. The middle view is towards the current location of the Crooked River Winery reception buildings, and the bottom view looks across the Crooked River towards hills to the south of Gerringong.

Source: From a photo of the 'Homeleigh' property by R.P Moore 379 Kent Street Sydney, in the collection of Geoff Bailey, Homeleigh Gerringong). The remains of the road portion shown in these photos constitutes heritage recording G2B H401, refer Section 8.4.1.

Note: This road portion is shown in a 1920s photograph of the *Homeleigh* property, (refer Figure 7.14 in Section 7.1.5).

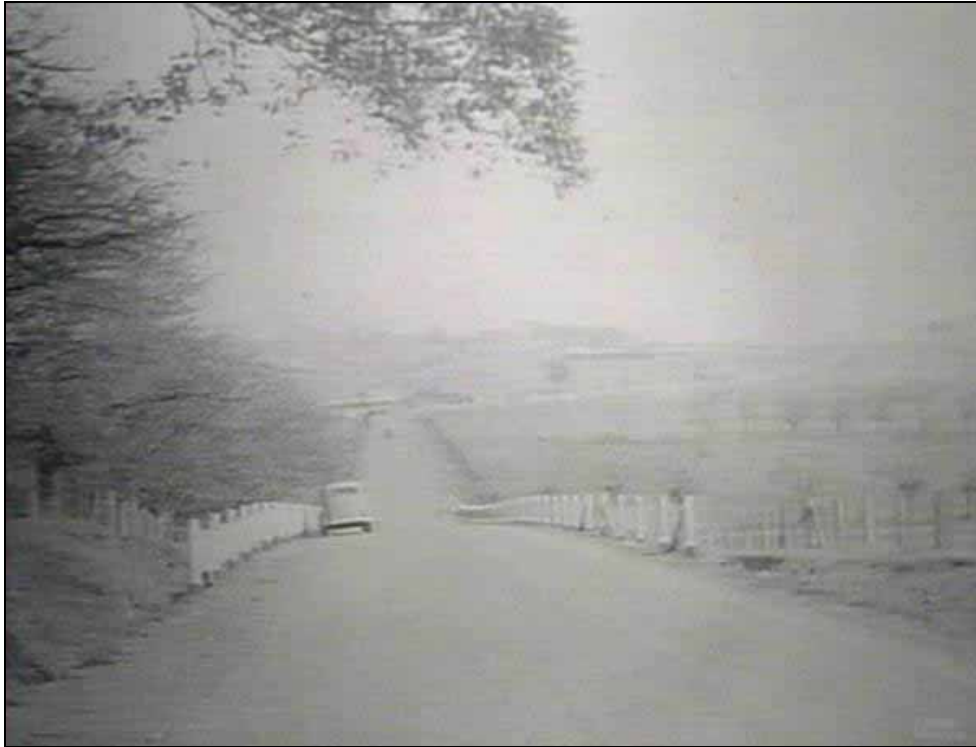
Figure 7.15: View looking southwards along the new 'Omega Deviation' (Gerringong Bypass), State Highway 1, from front of *Renfrew Park*, Sep 1938

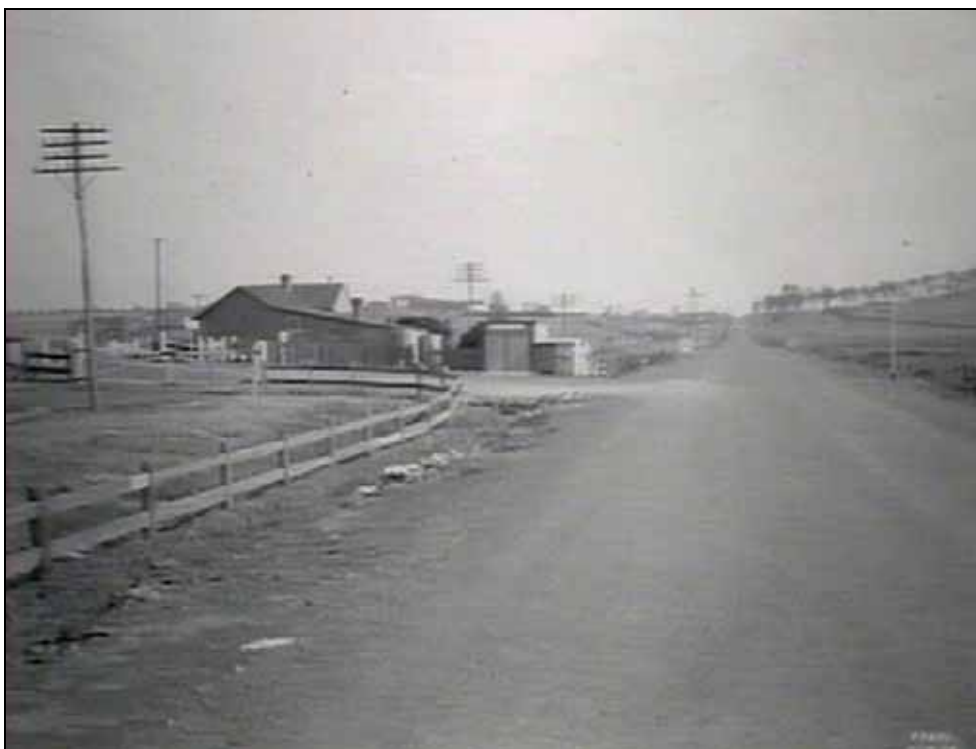
Figure 7.16: View looking south-west along the 'Omega Deviation' in 1938, opposite the intersection with Fern Street. Note the Omega Stationmasters residence in the middle distance

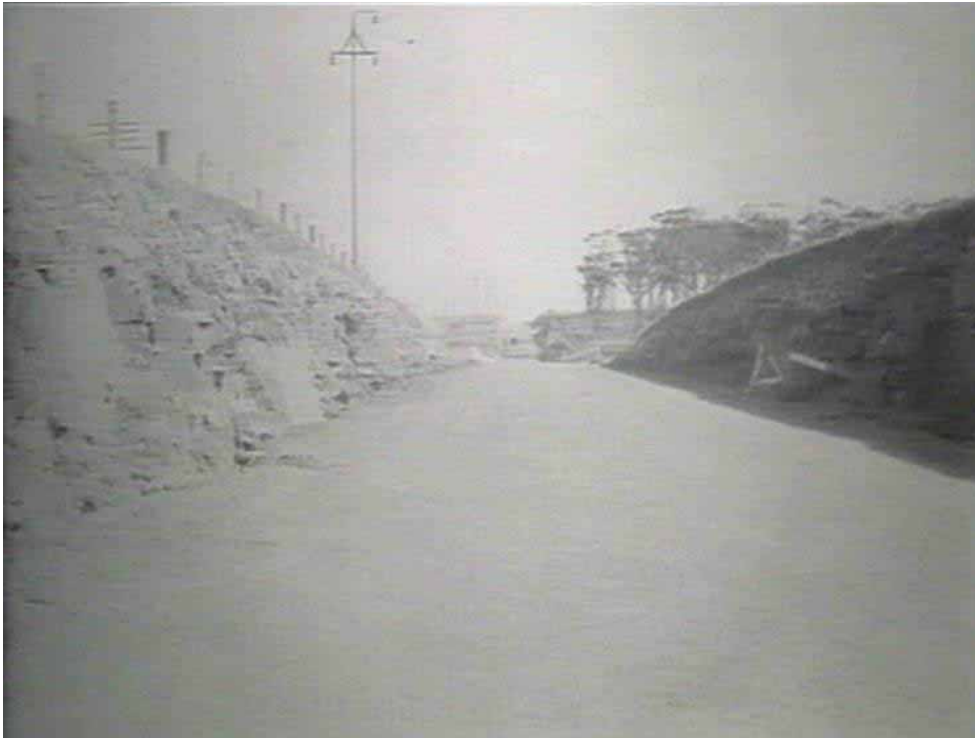
Figure 7.17: View of rock cuttings along the 'Omega Deviation', in 1938 looking south-west

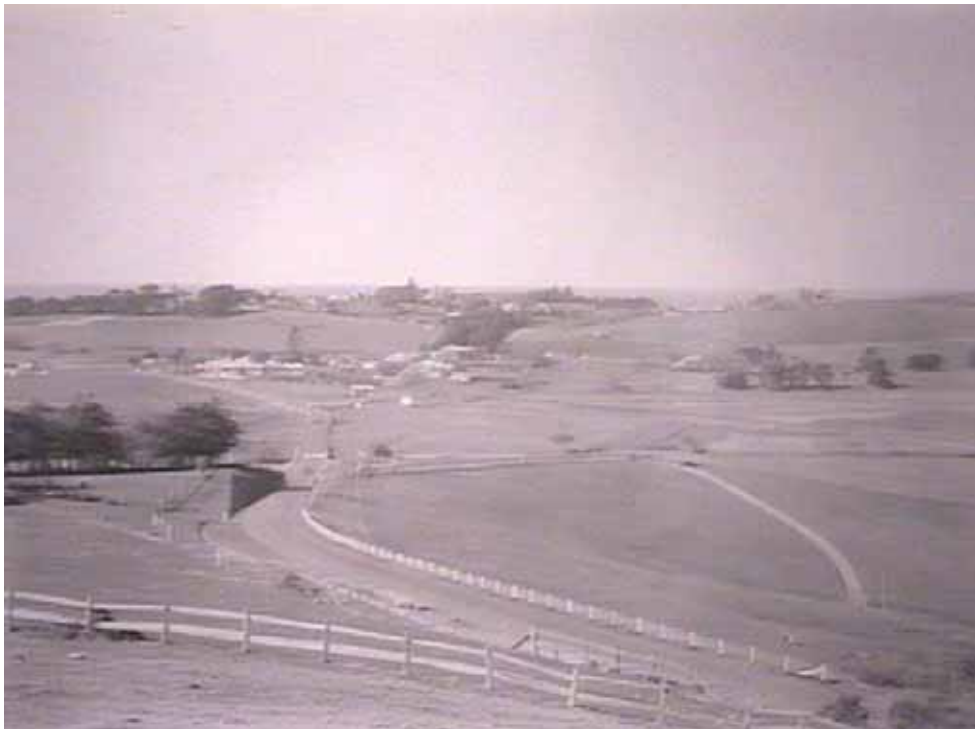
Figure 7.18: View of the southern end of the Gerringong Bypass completed in 1936, looking east. This section of the bypass cut off a number of bends, shown in the 1920s view, Figure 7.14.

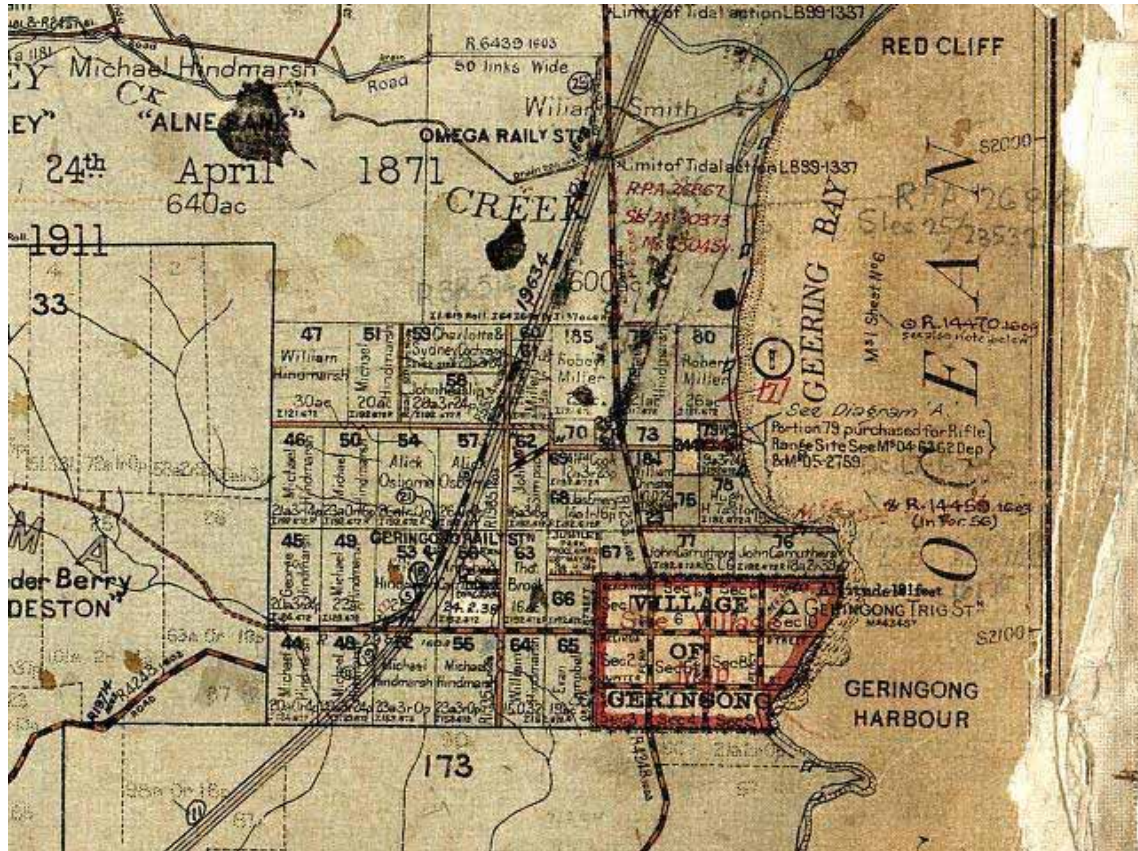
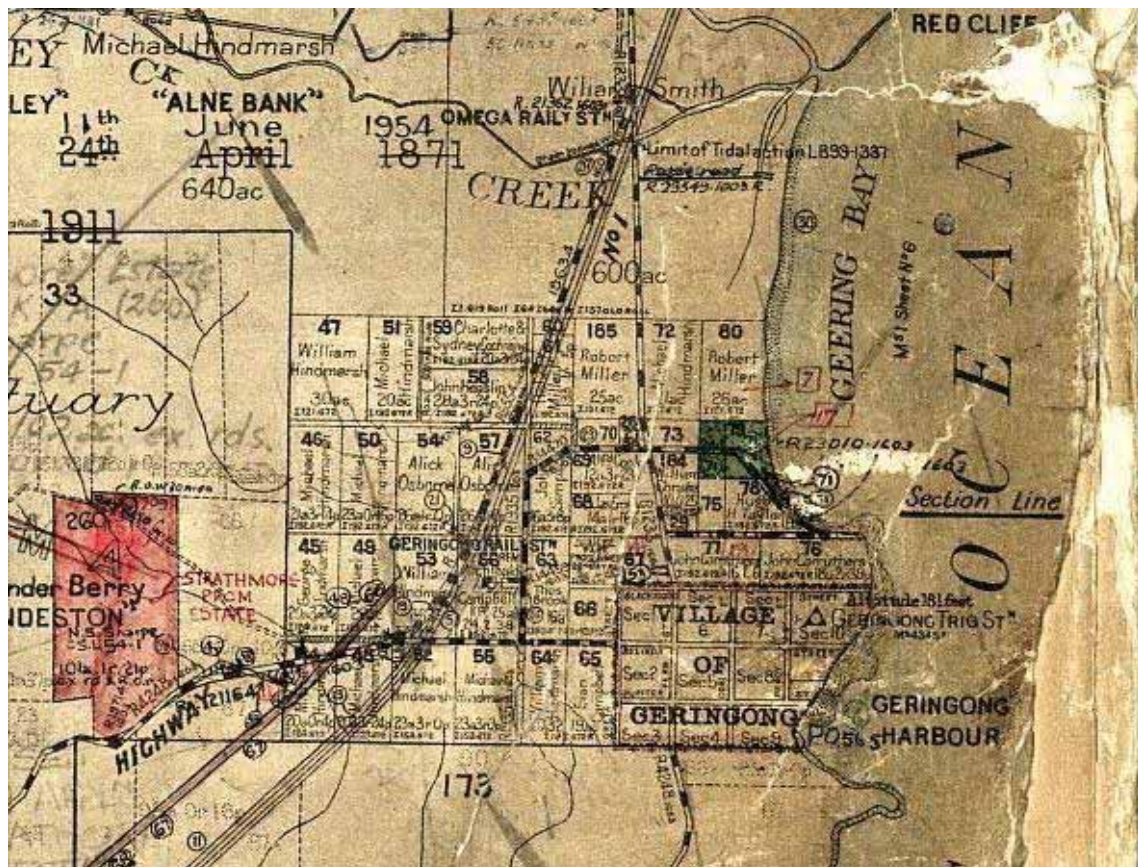
Figure 7.19: Extracts from the Parish map of Broughton 6<sup>th</sup> Edition (above) and the 7<sup>th</sup> Edition (below) showing alterations to the local road network arising from the Gerringsong bypass, constructed in 1938

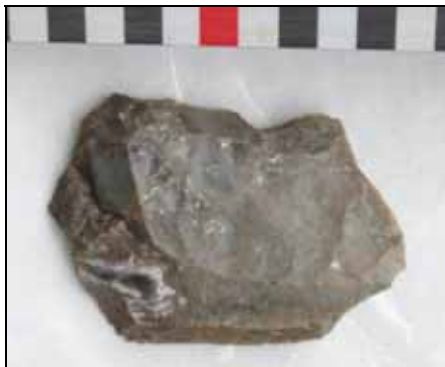
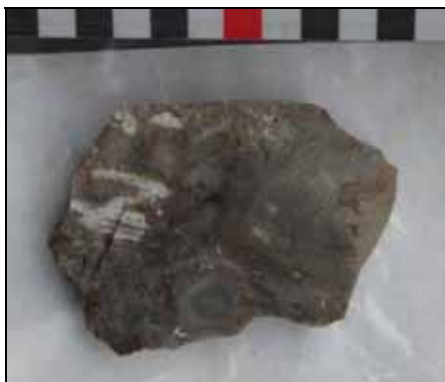
- 1) Light grey green fine grained siliceous material (rhyolite?) flake, five per cent reef cortex, focal platform 49 x 34 x 7 mm (Figure 8.3)

Figure 8.3: Dorsal (top) and ventral (bottom) sides of artefact from G2B A5. (Scale is in 5 mm increments)

Both hatchets were provided to the Gerringong historical society and form part of their permanent collection. One of the recovered artefacts was inspected during the current inspection (Figure 8.3). This was noted as being recovered in September 1999 at a depth of 10 cm during excavation to plant a tree.

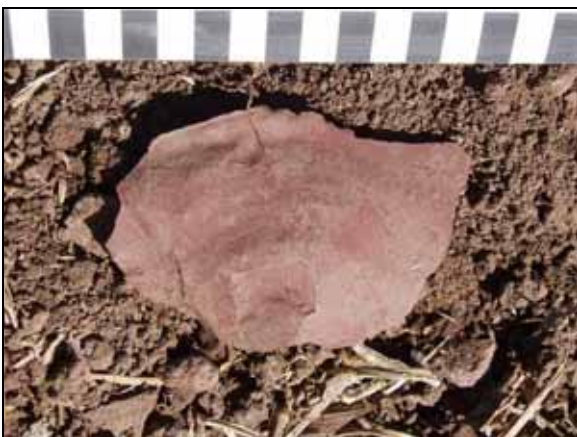
- 1) Dark red-brown fine grained rhyolite flake, focal platform, 55 x 57 x 10 mm

Figure 8.7: Ventral side of artefact at G2B A6 (scale in 5 mm increments)

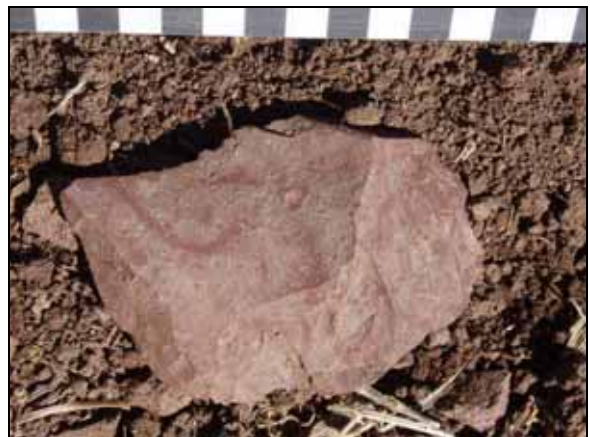
Figure 8.8: Dorsal side of artefact at G2B A6 (scale in 5 mm increments)

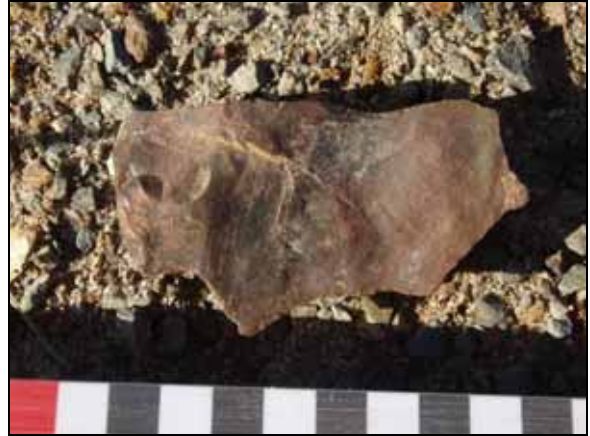
Figure 8.10: Ventral side of artefact one. (Scale in 5 mm increments)

- 1) Faintly banded red-grey brown fine grained siliceous material (possibly chert) utilised flake, (299437.6152979) focal platform, use polish associated with margins of flake as well as ridges on dorsal side (possibly indicating use prior to flake detachment), two per cent reef cortex, 42 x 24 x 13 mm
- 2) Translucent quartz broken flake, (301299.6155567) possible secondary flaking along one margin 36 x 17 x 5 mm
- 3) Dark grey to black fine grained siliceous quartzite broken pebble (manuport), (301289.6155514) 75 per cent well developed patina (alluvial pebble cortex) 68 x 52 x 40 mm

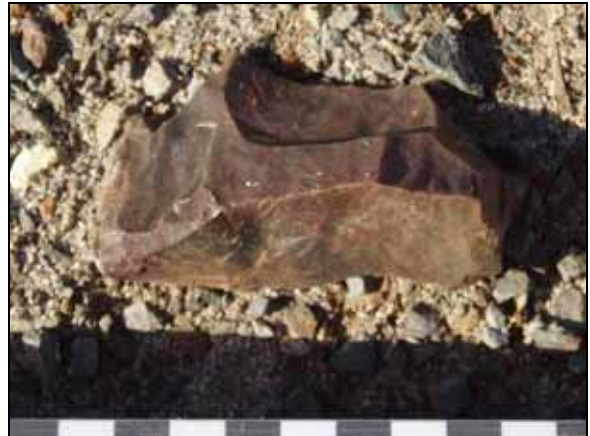
Figure 8.12: Dorsal side of artefact one

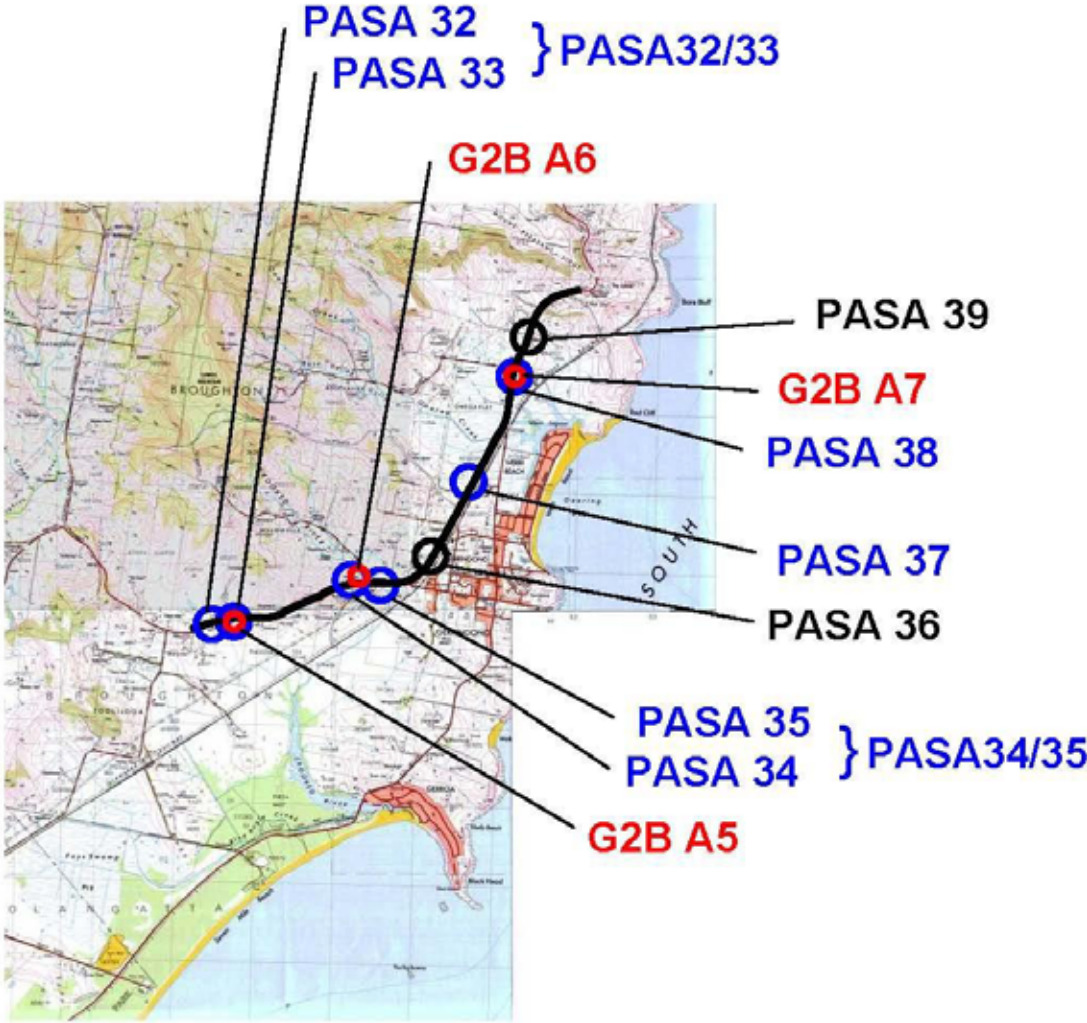
Figure 8.32: Aboriginal archaeological sites and potential archaeologically sensitive areas within the Gerringong upgrade (basemap consists of extracts from Gerroa and Kiama 1:25,000 topographic maps Second Editions L&PI)

- Artefact occurrence
- Potential archaeologically sensitive area (PASA) included in proposed test excavation program
- Potential archaeologically sensitive area (PASA) not included in proposed test excavation program
- Proposal alignment

This chapter provides descriptions of Aboriginal and Non-Aboriginal heritage recordings within or in close proximity to the Gerringong upgrade study area. A summary of the recordings are presented in Table 8.1, Table 8.2, Table 8.3 and Table 8.4, and locations are shown in Figure 8.32 and Figure 8.109 at a small scale and on large scale aerial photography in Appendix A.

Nine potential archaeologically sensitive areas have been identified within the Gerringong upgrade study area. These are PASA 31, PASA 32, PASA 33, PASA 34, PASA 35, PASA 36, PASA 37, PASA 38 and PASA 39. Two of the potential archaeologically sensitive areas are associated with recorded surface artefacts (site recording G2B A7 with PASA 38 and G2B A6 with PASA 34). Descriptions of each potential archaeologically sensitive area, together with landform and map grid references are presented in Table 8.2. Photos of each potential archaeologically sensitive area are presented with the following text. The location of each recording is shown in Figure 8.32 and Appendix A.

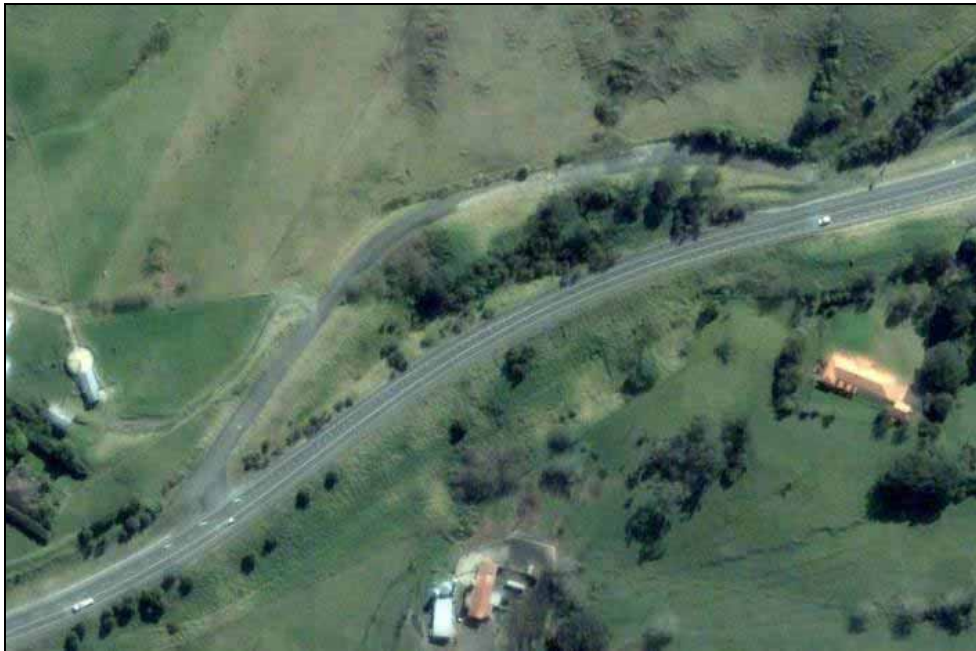
Figure 8.58: Aerial view of highway remnant G2B H33 (Google Earth image 2010)

The remnant road portion was bypassed by the construction of the current, straighter and wider carriageway immediately to the south. In this area the current highway incorporates the ends of both north and southbound climbing lanes. A review of aerial photography and topographic mapping indicates that the remnant road portion was bypassed sometime between 1992 and 2005.

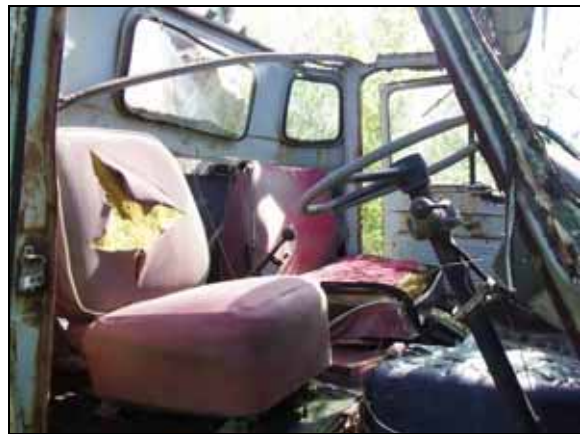
Figure 8.67: G2B H35 – Detail of cabin of disused 1960s COMMER tip up truck

This recording consists of a group of disused vehicles and associated mechanical and related debris, all in a poor condition and partly overgrown within a bamboo thicket. These items are situated on the eastern side of the current highway, approximately 150 m north of the Belinda Street intersection at Gerringong and appear to occupy the backyard of a residence situated further to the south. Some of the items may be situated within, or partly within the current highway easement. The assemblage as a whole is suggestive of a former depot for heavy vehicle and machinery.
